OBSERVATIONS ON THE BEHAVIOR OF BUILDINGS IN THE ROMANIA EARTHQUAKE OF MARCH 4, 1977

NBS SPECIAL PUBLICATION 490

Observations are presented of the damage to buildings resulting from the earthquake of March 4, 1977 in Romania. The report was prepared by engineers from the National Bureau of Standards who participated as members of the U.S. government team dispatched to Romania under the auspices of the Office of Foreign Disaster Assistance, Agency for International Development. A summary of the team's activities is included. Background data on the seismic history of Romania, the characteristics of the earthquake and descriptions of damage to specific buildings are also included. The types of building construction and the history of the development of seismic design requirements for buildings in Romania are discussed. Recommendations are presented for needed building research based on the observations.

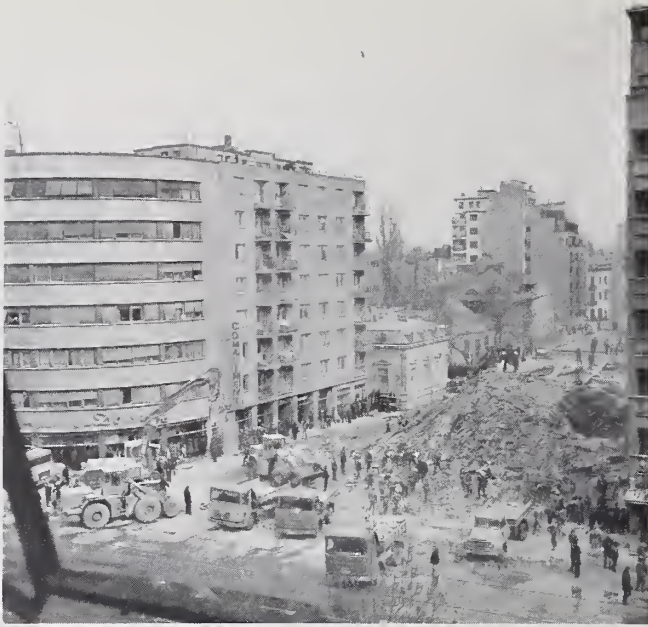
Figures 3.2 to 3.6 exhibit the remains of four apartment buildings that were totally destroyed during the earthquake. These photographs were taken by an INCERC survey team before removal of the debris. It should be noted that by March 14, the day the U.S. technical team arrived in Bucharest, all of the rubble from these and most other destroyed building sites had been completely cleared.

A peculiar phenomenon associated with the collapse of the older structures is evidenced by the extensive pulverization of the concrete as indicated in Figures 3.2 and 3.4. A member of the INCERC team that examined wrecked structures immediately after the earthquake noted that in many instances the concrete had disintegrated completely and a haze of dust particles hung in the air surrounding the sites. This pulverization effect, also noted during the November 1940 earthquake (see Ref. 3 and Section 2.3.2), may possibly be attributed to the cumulative degradation of concrete through exposure to cyclic loading during past earthquakes. Well-rounded ends of story-high concrete columns that had pried loose and fallen to the ground (see, for instance, Figures 3.3 and 3.6), as opposed to jagged ends normally found in concrete failures, may be evidence of internal pulverization of concrete in the joints attributable to past extreme events. It should also be noted that the use of relatively low-strength concrete (as low as grade B100 with approximately 10 MN/m^2 cube strength) was prevalent in the construction of pre-1940 buildings.

Figure 3.2. Cafe Scala apartment building totally destroyed by the earthquake.

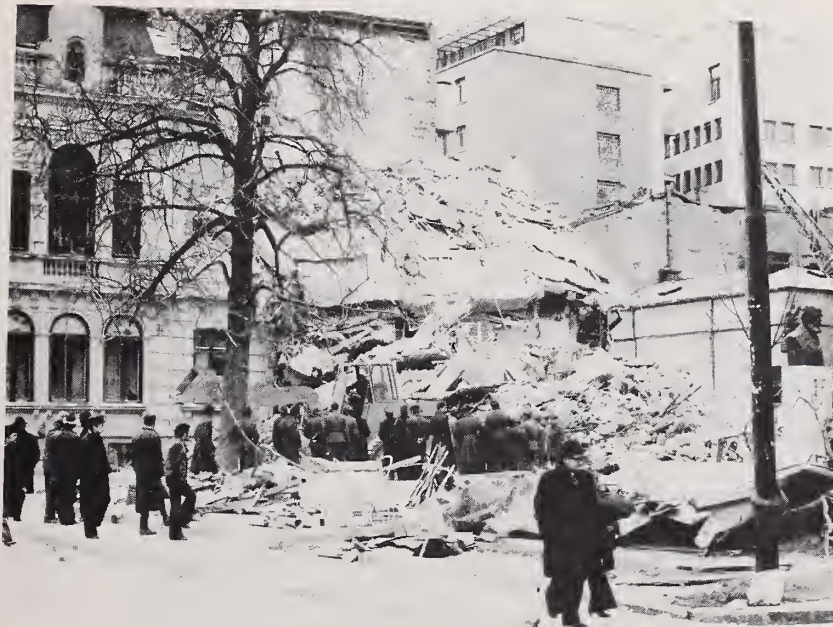
Figure 3.9. Partial collapse of three-story residential building on Snagov Street.

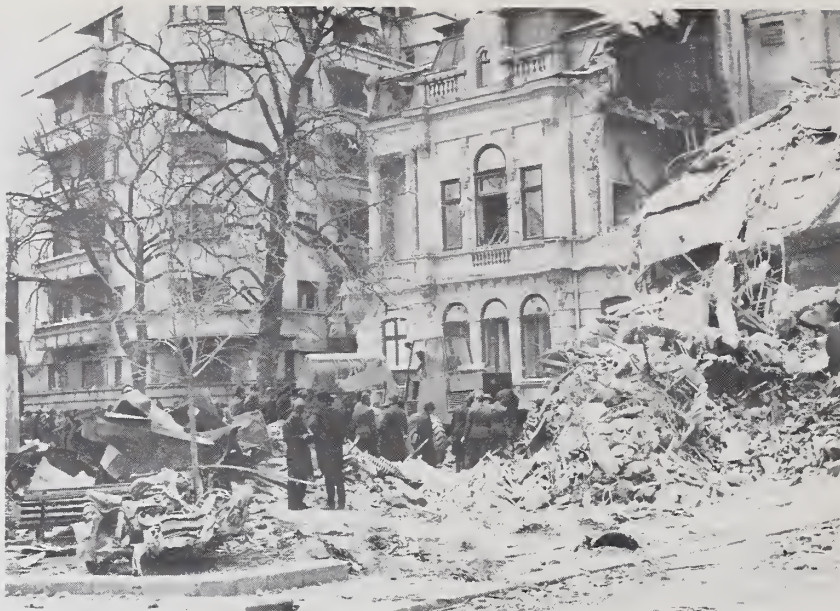
Figure 3.10. Close-up view of the collapsed bay of the building on Snagov Street.

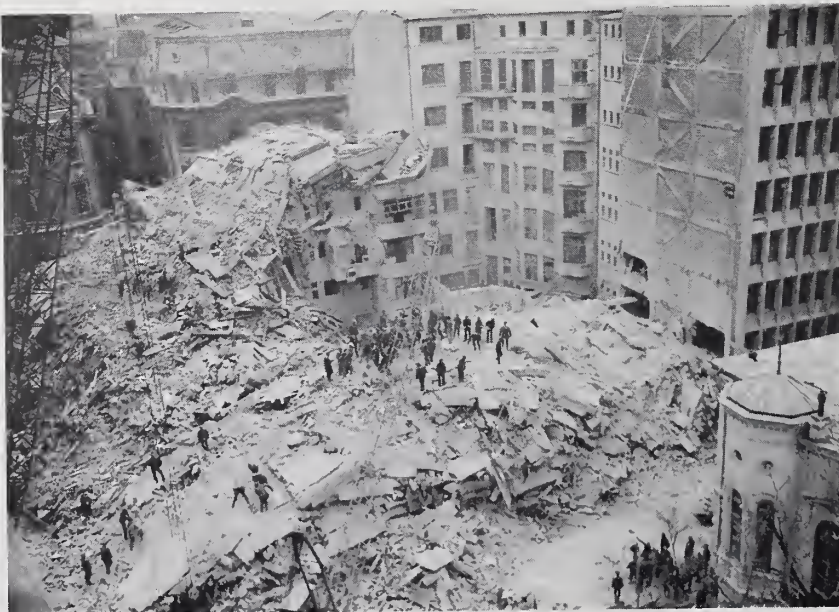
Figure 3.11. General view of the collapse of the multistory Continental building before removal of the wreckage.

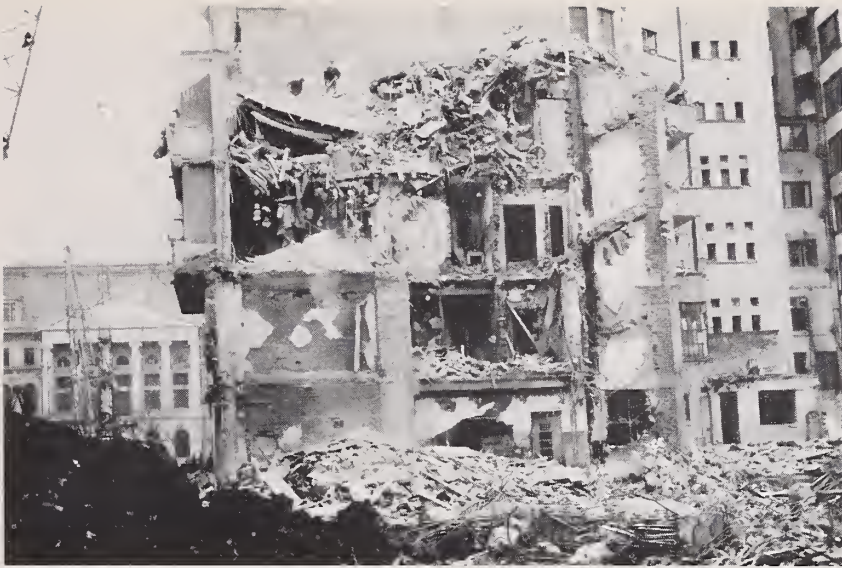
Except for a portion of the left wing, this structure was leveled by the earthquake. It was learned that a 19-year old boy trapped within that section was saved 11 days after the earthquake. Figure 3.12, taken the same day, shows the structural configuration of the left wing which was three bays deep. Note the common use of double and single wythe brick infill walls at the exterior and interior of the building, respectively. Although not designed to function structurally, these walls invariably took the brunt of the earthquake-induced lateral forces before failure.

Figure 3.12. View of Continental building after partial removal of debris.

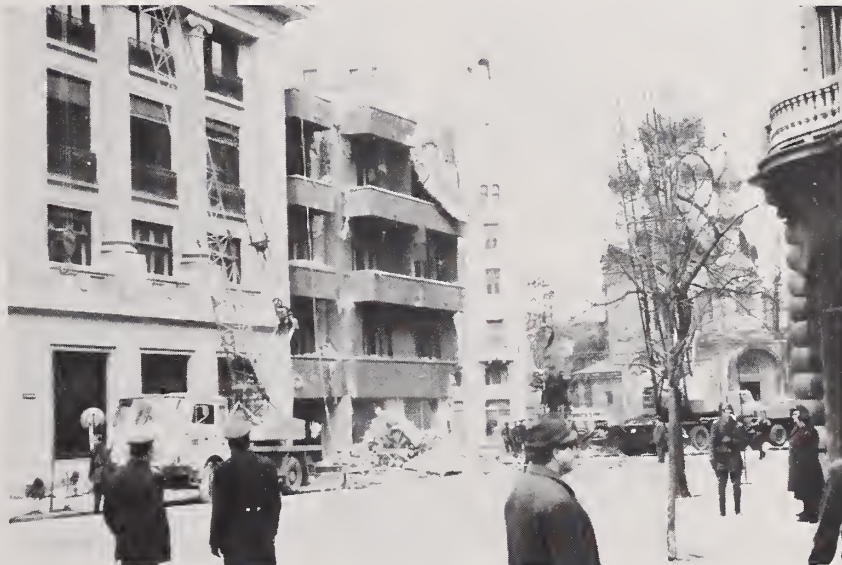
Figure 3.13. Standing left wing portion of Continental building with Russian church in the background.

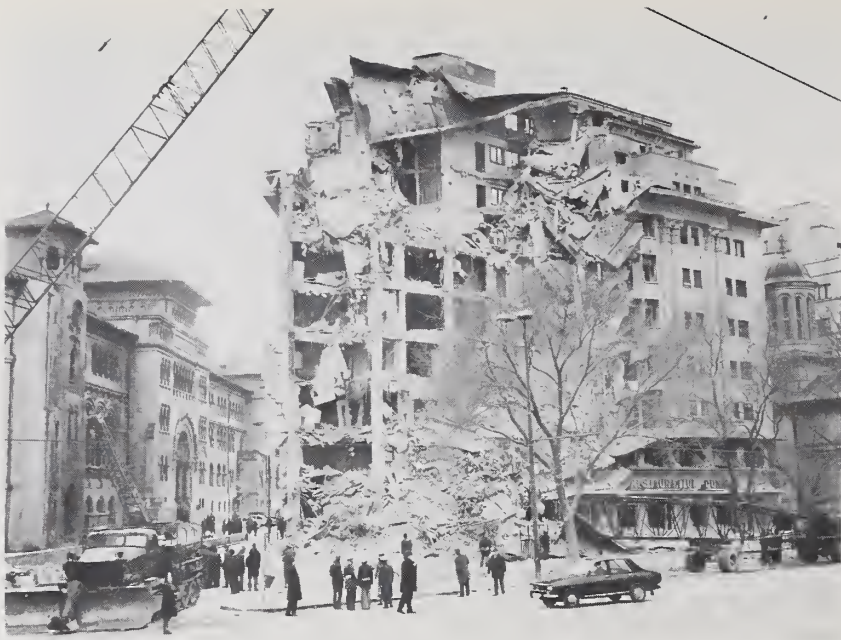
Figure 3.14. View of partially collapsed Dunres building before removal of debris.

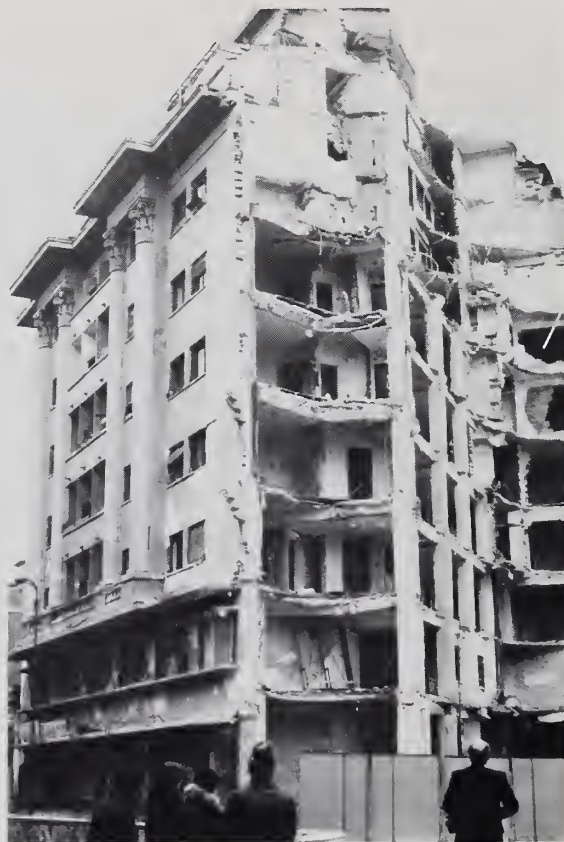
Figure 3.15. Southeast view of Dunres building after clearing of debris.

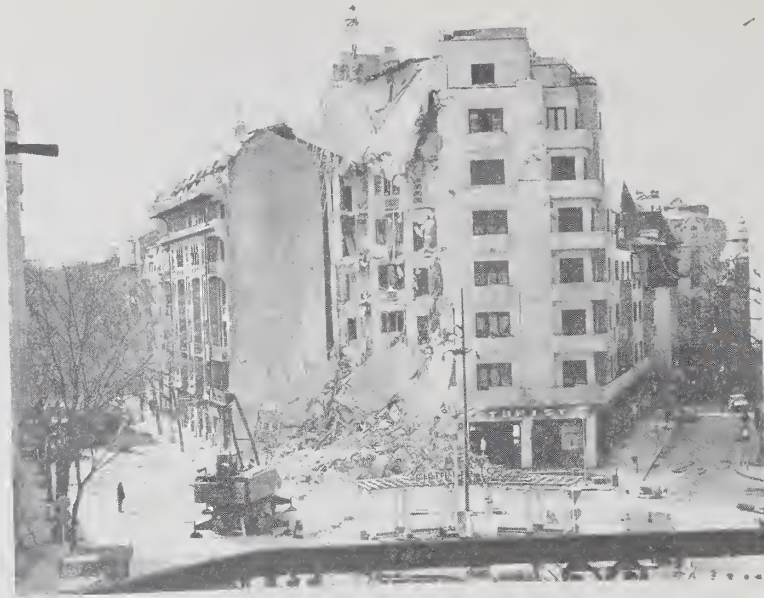
Figure 3.18. Partial collapse of Lido building.

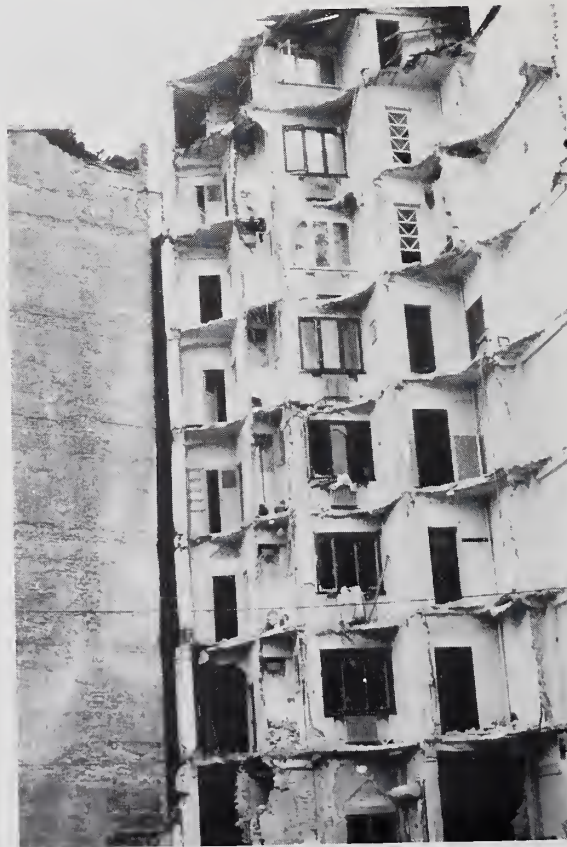
Figure 3.19. Close-up view of Lido building after removal of suspended wreckage.

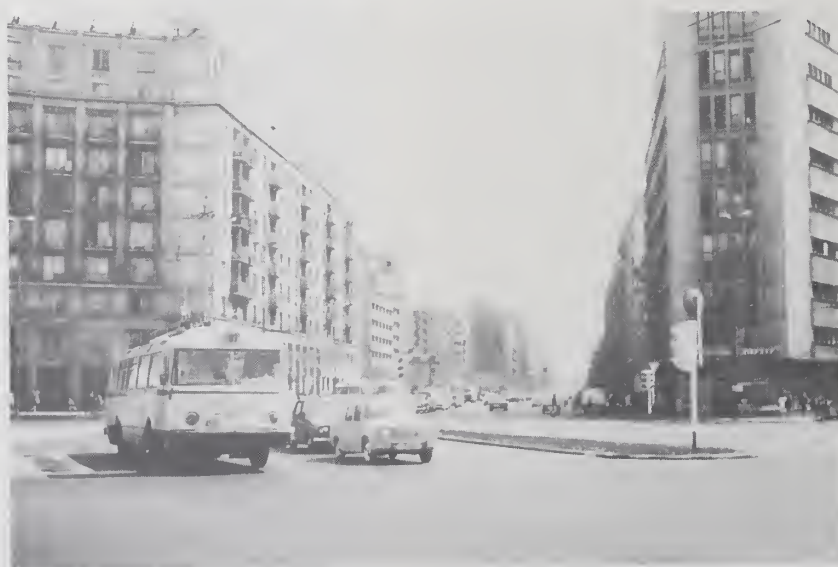
Figure 3.27. Scene of downtown Bucharest showing the Turist building before the earthquake.

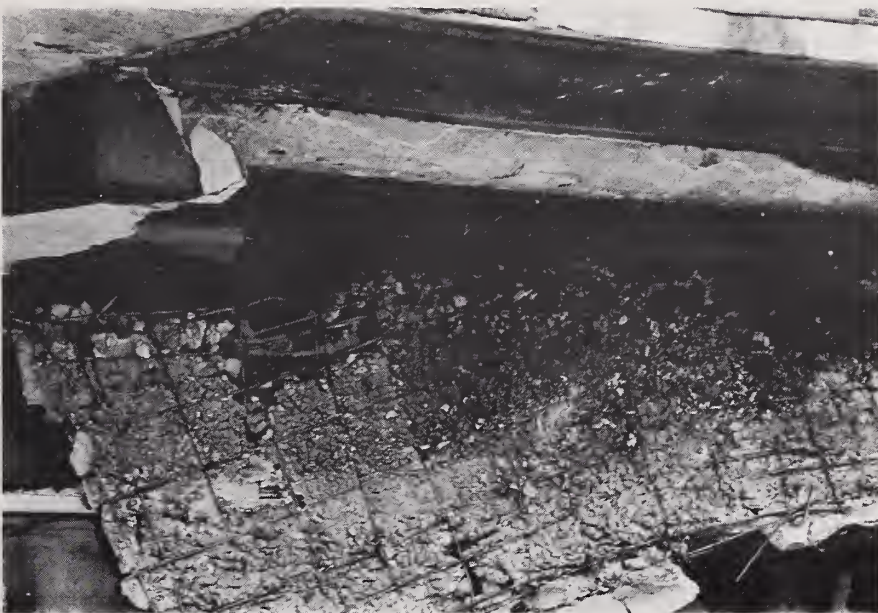
Figure 3.29. Close-up view of detached soffit of the canopy over the sidewalk.

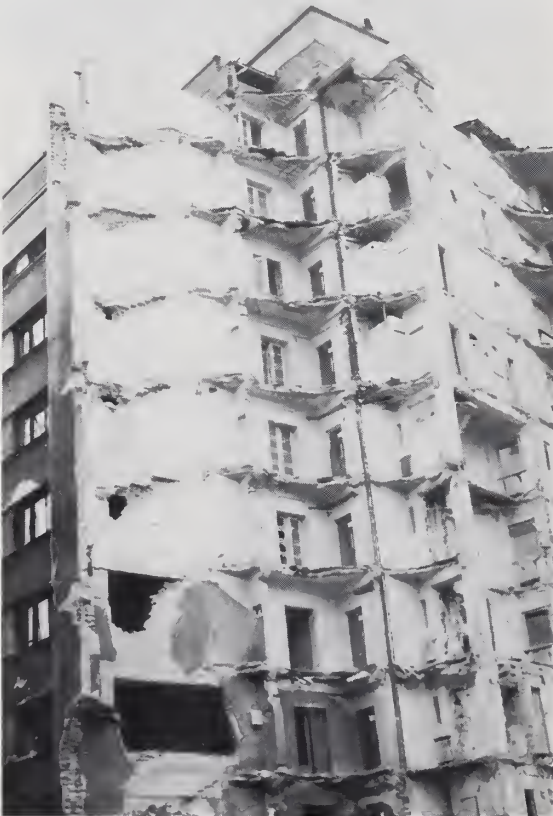
Figure 3.35. Left view of the collapse Metalimport building.

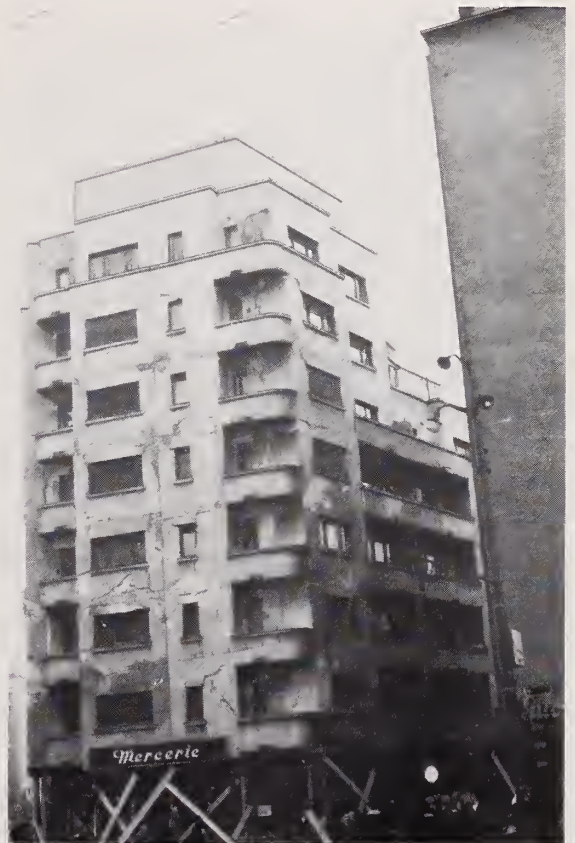
Figure 3.37. Another view of Mercerie building showing configuration of upper story setbacks.

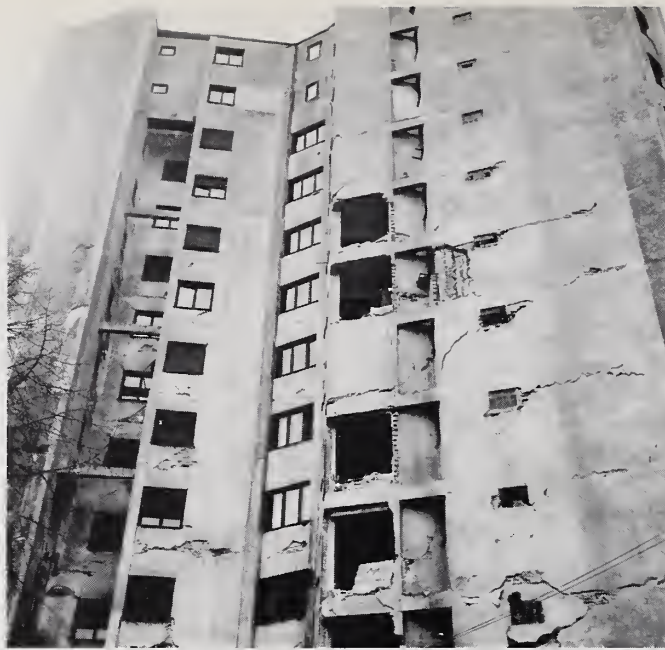
Figure 3.38. Damage of multistory Ambassador Hotel, rear view.

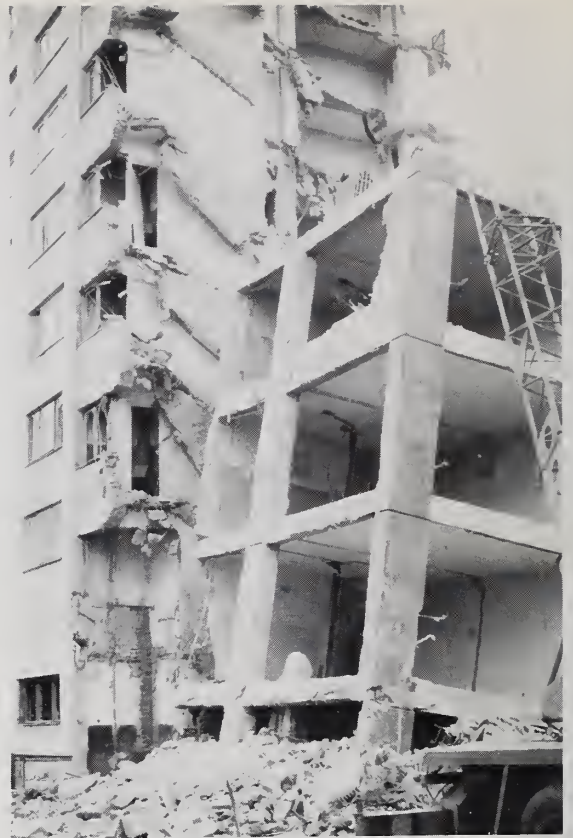
Figure 3.42. Rear corner view of collapsed end bays after tearing down of walls by wrecking crew.

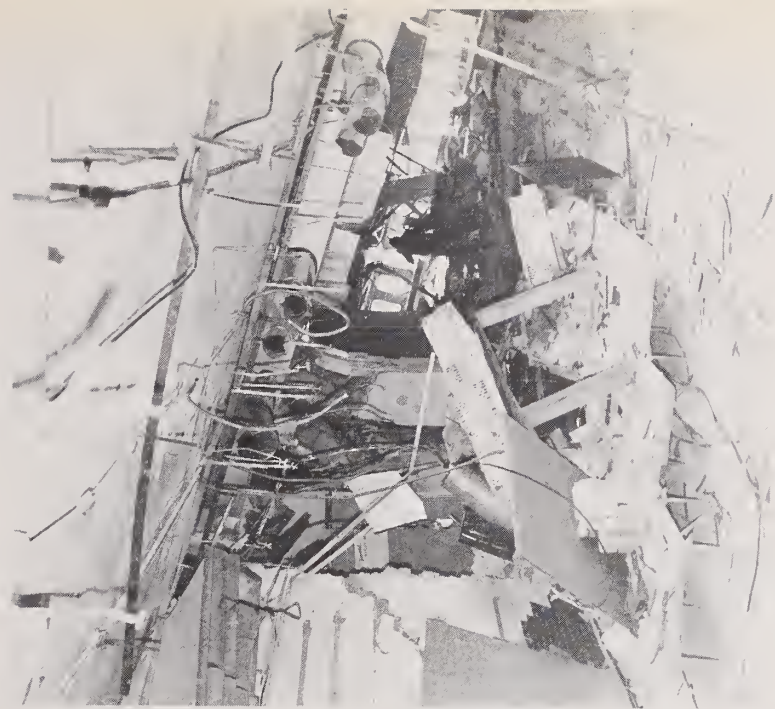
Figure 3.53. Inside view of the main computer room in the second story.

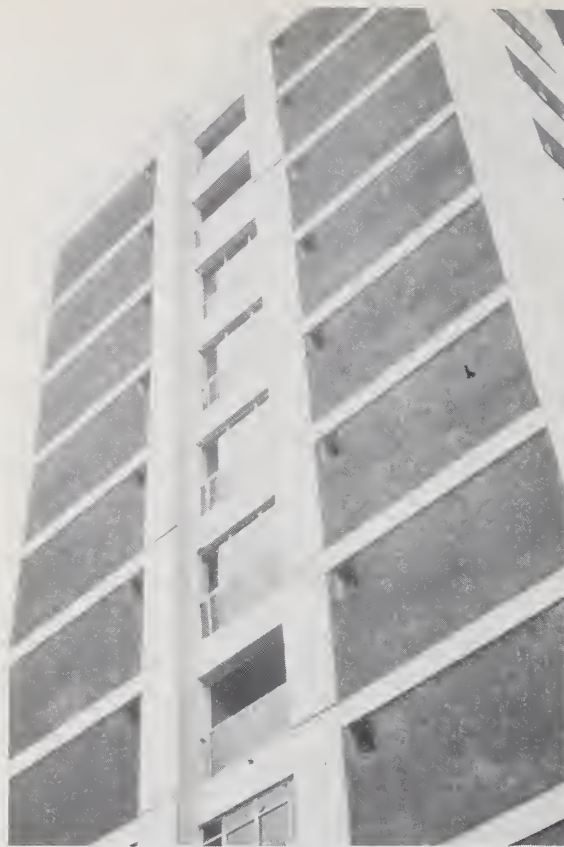
Figure 3.58. End view of upper stories of Building 16.

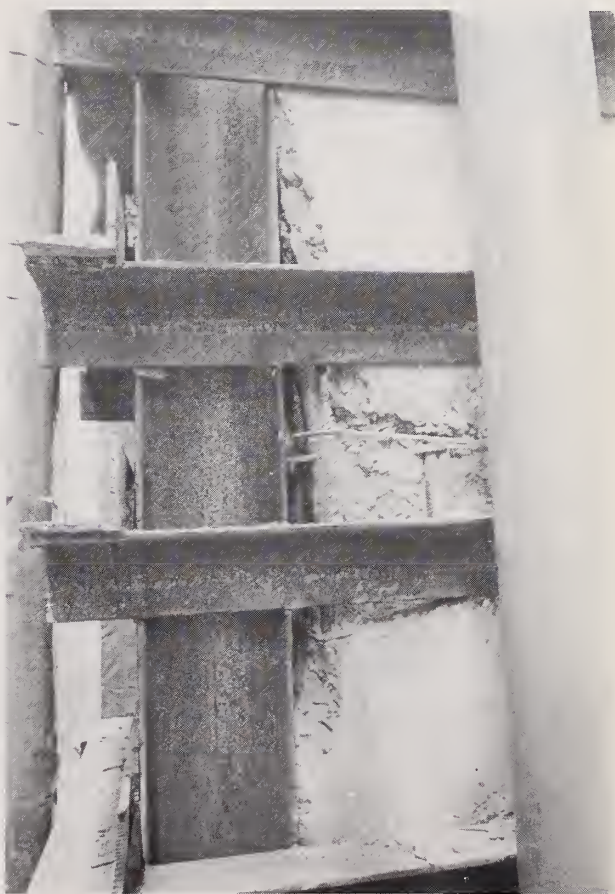
Figure 3.65. Close-up view of steel framing used for confinement of ruptured column.

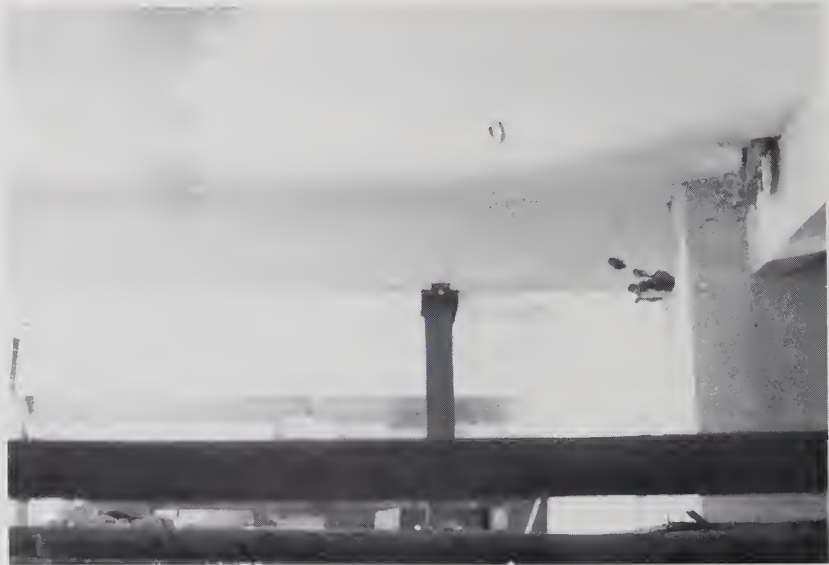
The next building examined was similarly a reinforced concrete frame structure in which the first story elements exhibited a similar but somewhat less extensive damage pattern. Figures 3.71 and 3.72 show two transverse beam failures characterized by diagonal cracking at the column supports. A close-up view of the beam shown in Figure 3.72 revealed two positive bars of unequal size and a single stirrup in the region of the spalled concrete. The smaller bar (in the background) appeared to have buckled. At another location, the spalled concrete at the top of a column (Figure 3.73) exposed a bent corner bar but no ties.

Figure 3.71. Shoring of damaged first story beam in multistory concrete frame building. (Building No. 18)

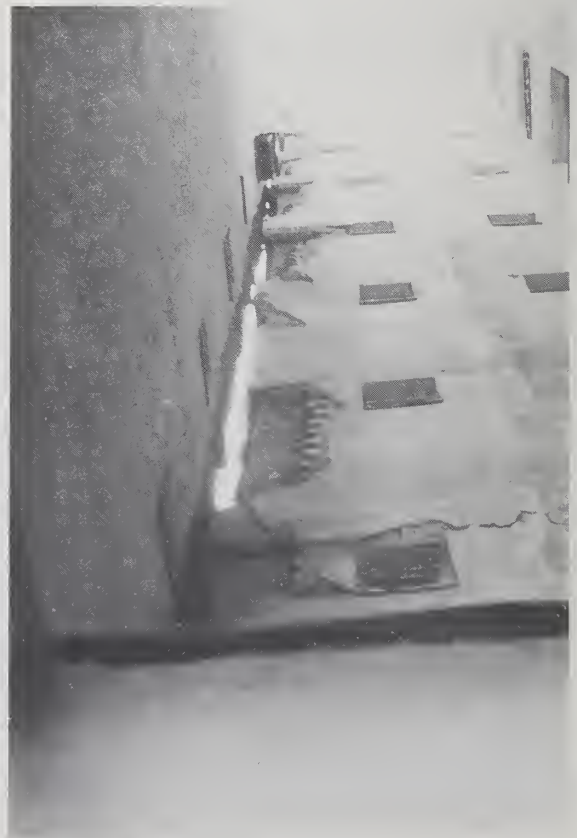
Figures 3.83 and 3.84 are two opposite views of the damage which seemed to have occurred mostly in the frame structure including the rupture of a corner column in the story opposite the top of the next building.

Figure 3.83. Heavy pounding damage to buildings with adjacent corners.

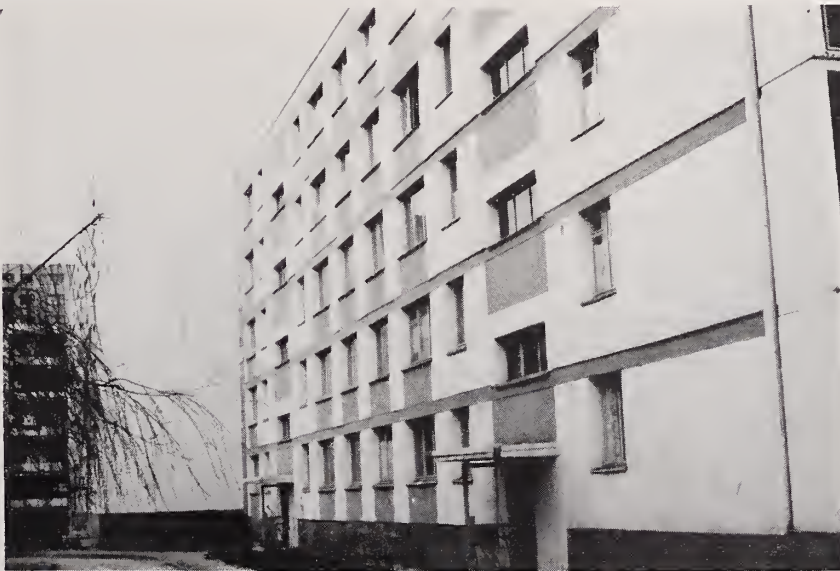
A number of apartment buildings of relatively recent construction were examined in the southern part of the city near Boulevard Magurele. These buildings are collectively identified by the number 19 on the map shown in Figure 2.2. The first building was a 5-story precast panel structure shown in Figures 3.85 and 3.86. No evidence of damage, not even signs of hairline cracks, was found inside or outside the building.

Figure 3.85. Front view of 5-story large panel building.

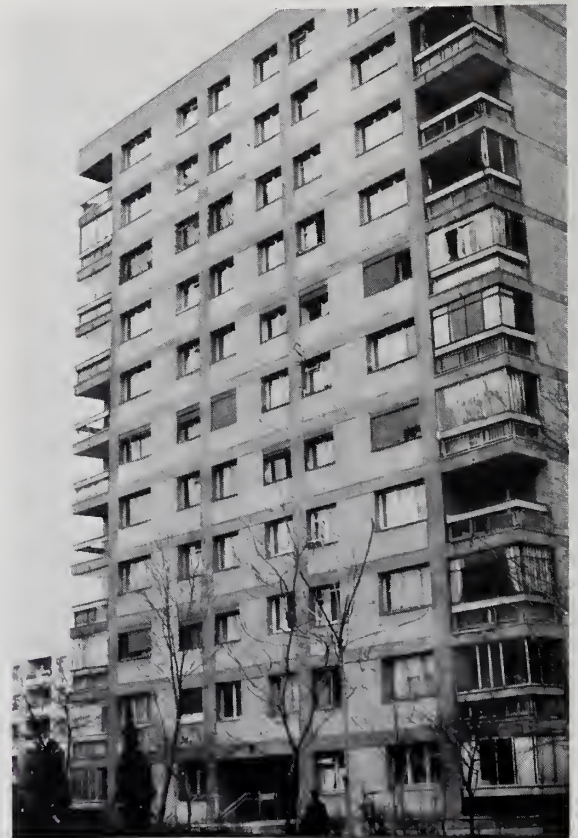
The second building, shown in Figure 3.87, was a 10-year old cast-in-place concrete shear wall structure in which breakage of window glass and appearance of hairline cracks near the first story stairway landing were the only visible signs of damage. This observation was also corroborated by the superintendent of the building. Because the first story was used for residential purposes, its stiffness was more compatible with the rest of the structure than would have been the case had that area been designed for store usage. Note the superior quality of the exposed masonry used in the construction of the end wall of the building.

Figure 3.87. Eleven-story shear wall building.

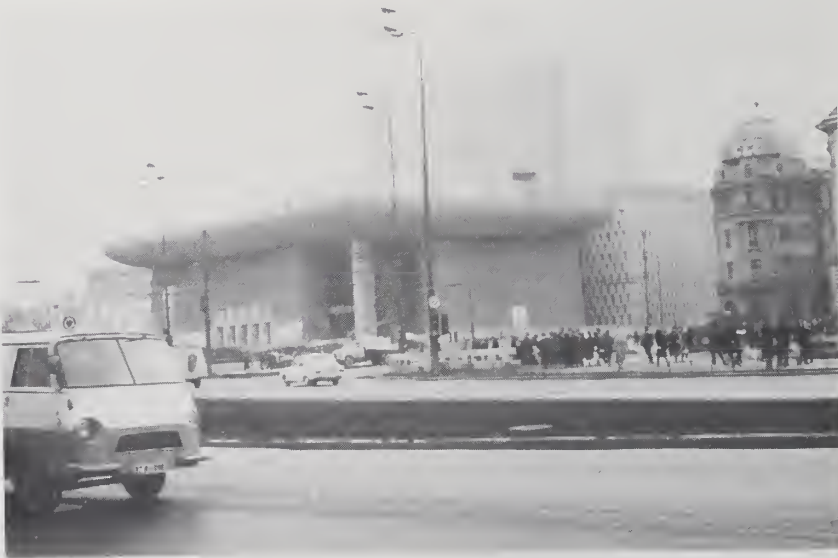
Figure 3.91. National Theater next to Intercontinental Hotel.

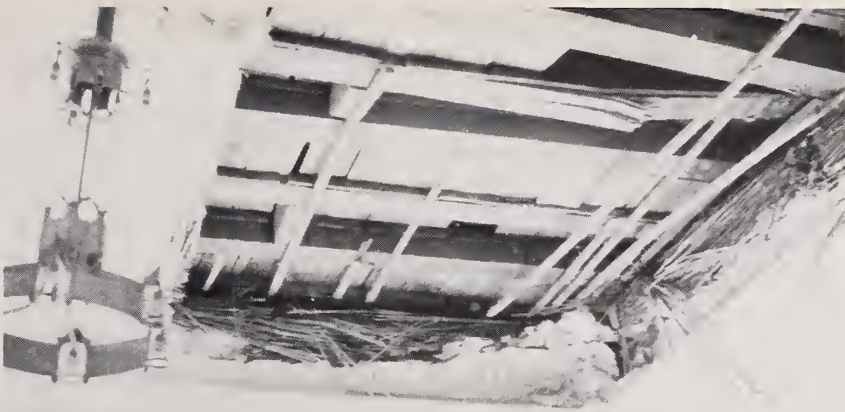
The second historical structure examined was the art museum (Figures 3.99-3.103). It was a massive masonry bearing wall building with a heavy timber floor system. Most of the damage was attributed to the collapse of the chimneys that had fallen inside and outside of the building. Figure 3.99 shows the damage caused to the exterior facade and balcony by a fallen chimney. In one instance, a cupola had fallen into the building and had damaged the flooring below. Figure 3.100 exhibits the exposed timbers of a floor damaged by falling debris. The floor joists were approximately 0.3m square, spaced at about 0.6m on centers. Falling debris had also caused breakage of a decorative skylight above one of the first story rooms (Figure 3.101). The brick walls in the first story, which were about 0.5m to 0.7m thick, were not seriously cracked, although a good deal of decorative plaster had spalled off both walls and the ceiling.

Figure 3.100. Partial collapse of the second story floor of the museum.

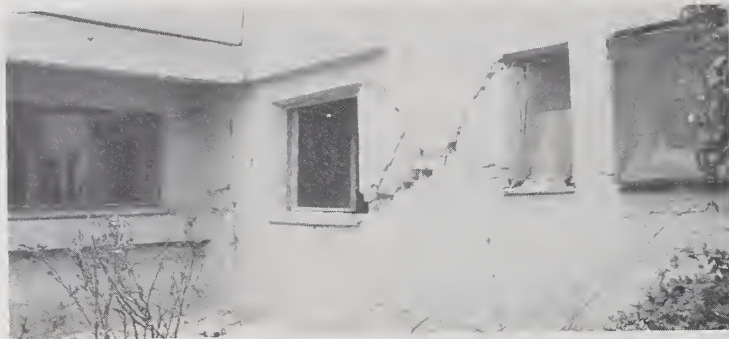
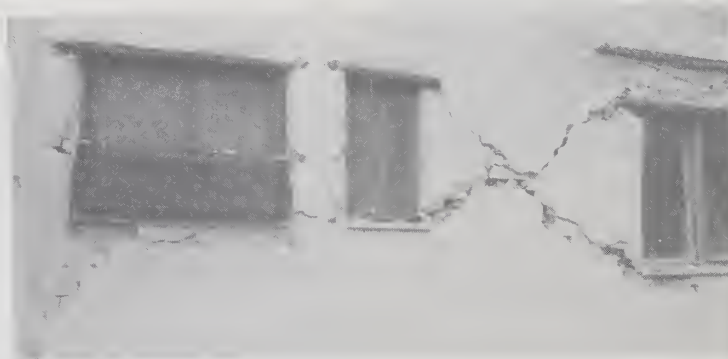
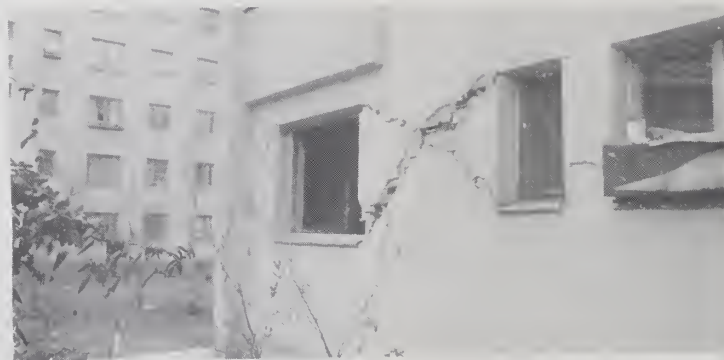
The third building examined was a 5-story unreinforced masonry load-bearing wall system. Two of the wings of the building shown in Figures 3.104 and 3.105 exhibited cracking of first story piers. The latter also shows the development of a major vertical crack between two first story abutting walls at one corner of the building. It appeared that most of the damage had occurred in the first story where many of the exterior piers exhibited severe diagonal cross cracking as shown in Figure 3.106. By reference to this figure, two distinct modes of failure can be identified. In each of the four different instances shown, the wide pier had attained its collapse limit state, characterized by through tension cracking along the diagonal(s), while the slender pier located next to it had developed horizontal flexure cracks at the ends (a first limit state), without appreciably losing its vertical load-bearing capacity.

Figure 3.106. Failure of first-story piers.

Figure 3.107. Damage of interior masonry wall.

Inside the first story, the solid interior walls were not as severely damaged (Figure 3.107) but most lintels above openings had received a good pounding (Figure 3.108). One of the repair schemes that was being considered for this building was the application of gunite over wire mesh on both sides of the first and second story walls. The Romanian engineers also expressed interest in learning more about the structural rehabilitation methods used in the United States, particularly tuckpointing of masonry and use of epoxy resins in the repair of concrete and masonry cracks.

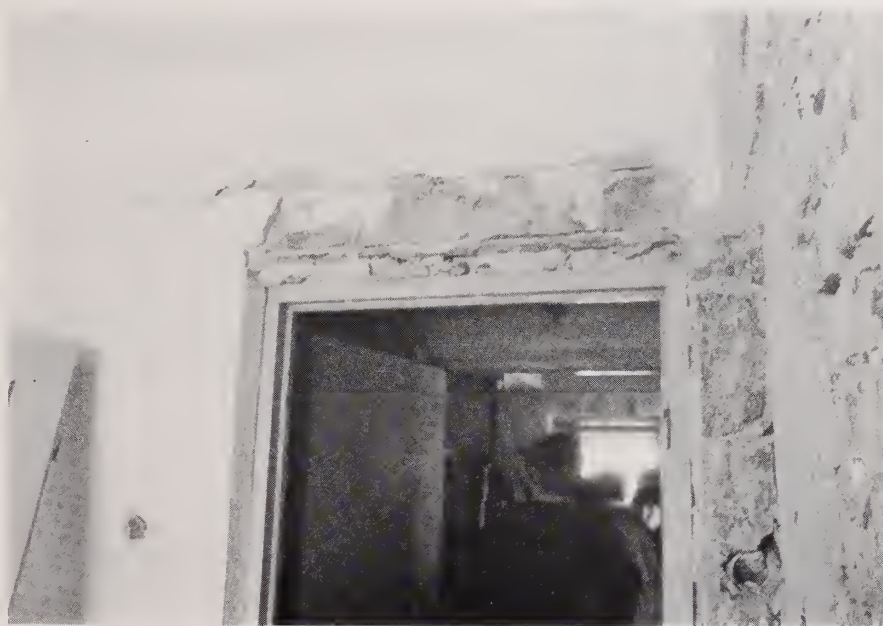
Elsewhere in the city, two or three instances of pounding damage between buildings were noted during the survey such as shown in Figure 3.109. There were also a number of buildings with partly missing roofs and fallen chimneys. Inspection of 10-story reinforced concrete shear wall buildings, some of which were reportedly erected quite recently using the slip-form method, revealed minor non-structural damage, mainly in the first story exterior insulation walls as seen in Figure 3.110.

Figure 3.108. Damage of lintel wall in first story.

Figure 3.109. Pounding damage between adjacent buildings.

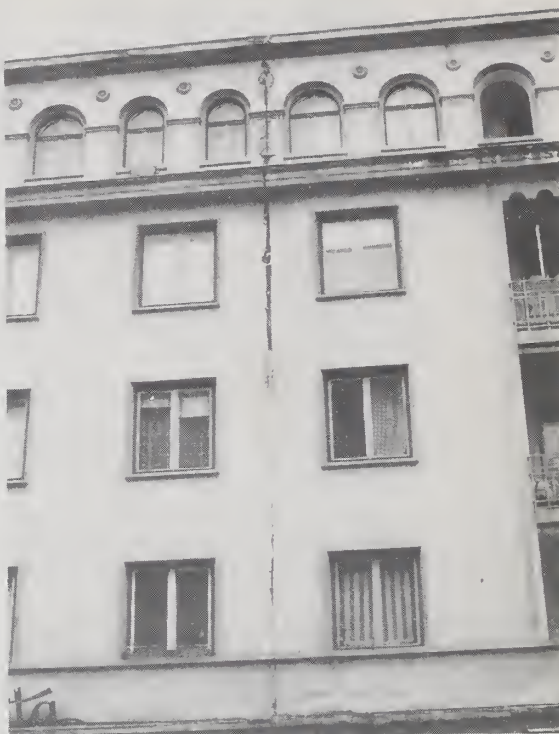
Figure 3.110. Cracking of facing wall in multistory apartment build
